Subject: RE: EMERGENCY-#3400 MAJOR FLOODING

Please note change of address:

1100 S. Flower St., Suite #3400, Los Angeles, CA 90015

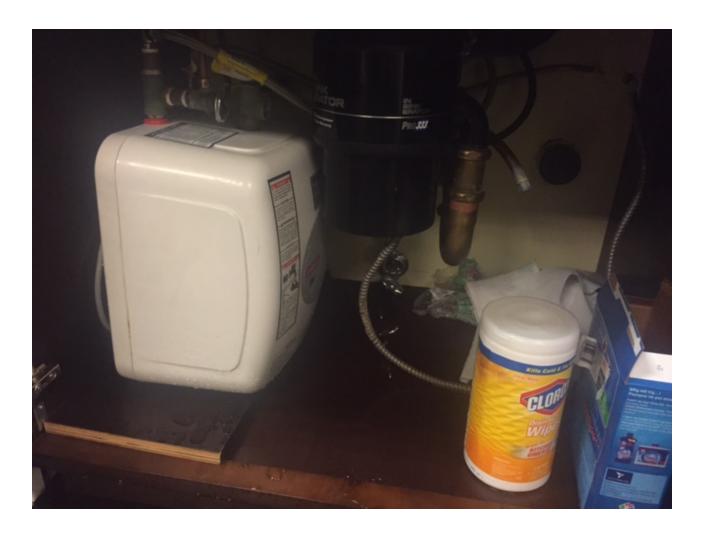
-IMG_3414.jpg-

- 3. I received word that the instahot that was installed yesterday (pic attached) was found in the building's recycling center. If this is the case, there is serious negligence from the Landlord as a trashed product was recirculated into our suite for functional use. Clearly this product was thrown out due to its defects and should have never been brought into our suite for use.

- Standing water found under the kitchen sink cabinetry where instahot was installed. When I came into the office this morning at roughly 7:50A, the instahot was spewing water out of a side seam of the unit.

As for the instahot that was installed yesterday and found spewing water this morning, we will want that completely removed and will want a new one installed. With regards to the type of new product to be installed, please confirm that it is the correct grade to handle the plumbing connection to both the sink and the dishwasher. During the install yesterday, it was connected to both of these.
